# Hyperspectral Earth Observation Instrument On ISS

TIVITA<sup>®</sup> Diaspective Vision  
Hyperspectral Camera Device

# Hyperspectral Images were Acquired Before, and During Crossclamping Round Markers Indicate Regions of Interest (ROI) for Subsequent Analysis

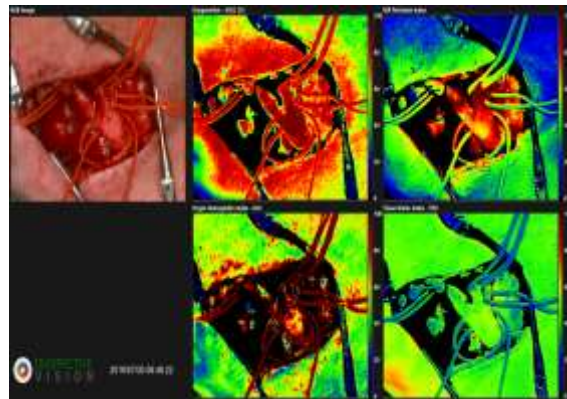
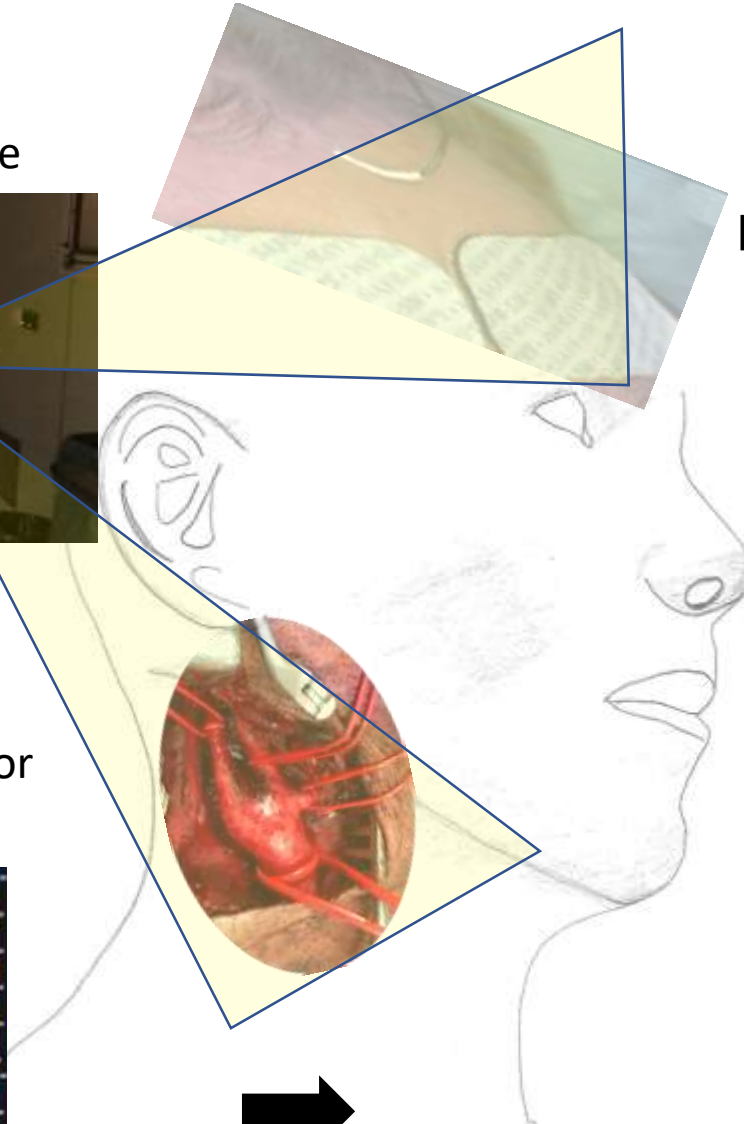
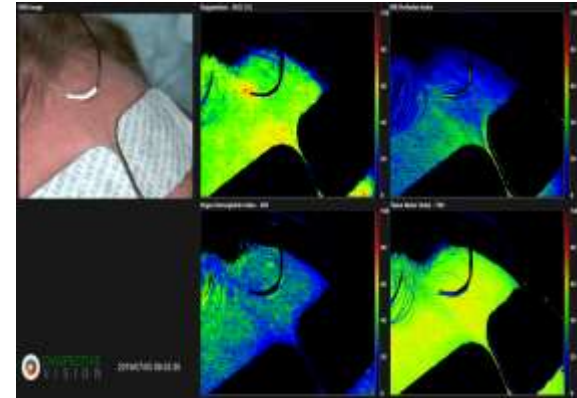
RGB and false color images for  
StO<sub>2</sub>, NIR, OHI and TWI

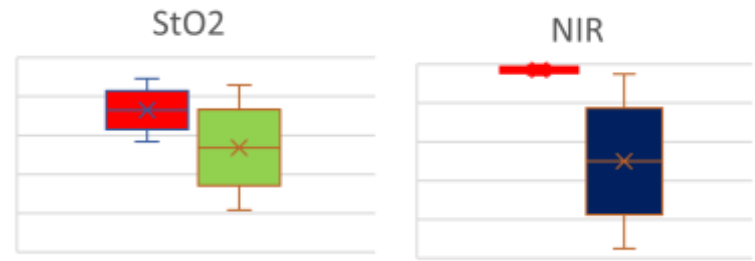
Image Analysis  
TIVITA Suite Tissue

Quantitative Data on:  
StO<sub>2</sub>, NIR, OHI and TWI

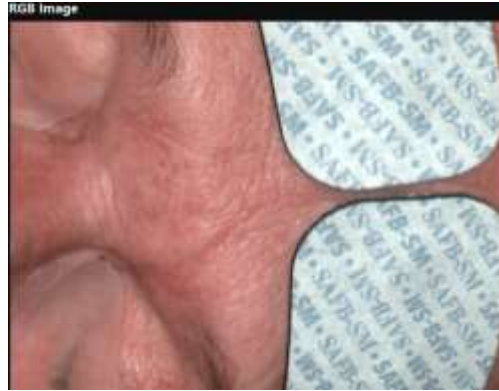
RGB Image before clamping

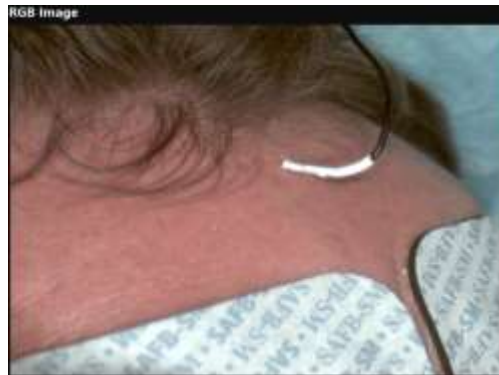
RGB Image during crossclamping

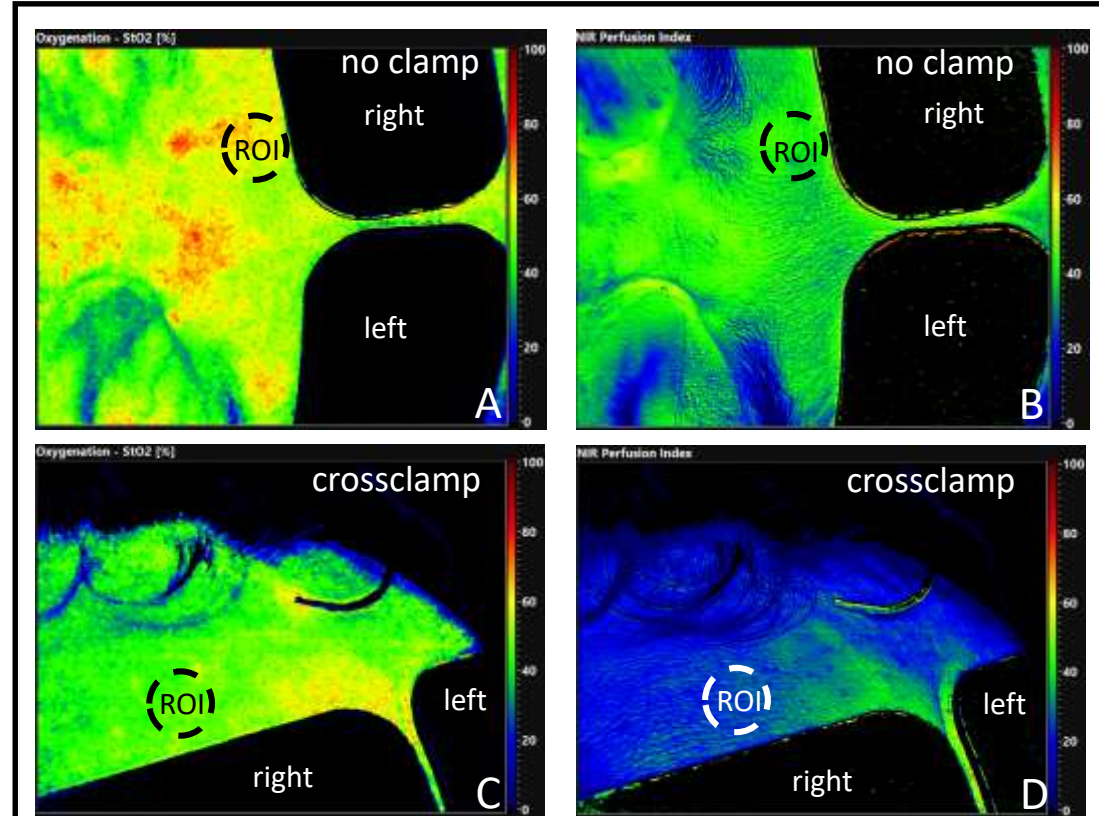
Patient with right CEA. False color hyperspectral images (HSI) for StO<sub>2</sub> (A) and NIR (B) before clamping and during crossclamping (C,D), respectively. Round markers represent the region of interest (ROI) for subsequent computational analysis of StO<sub>2</sub> and NIR. Images were acquired by TIVITA.

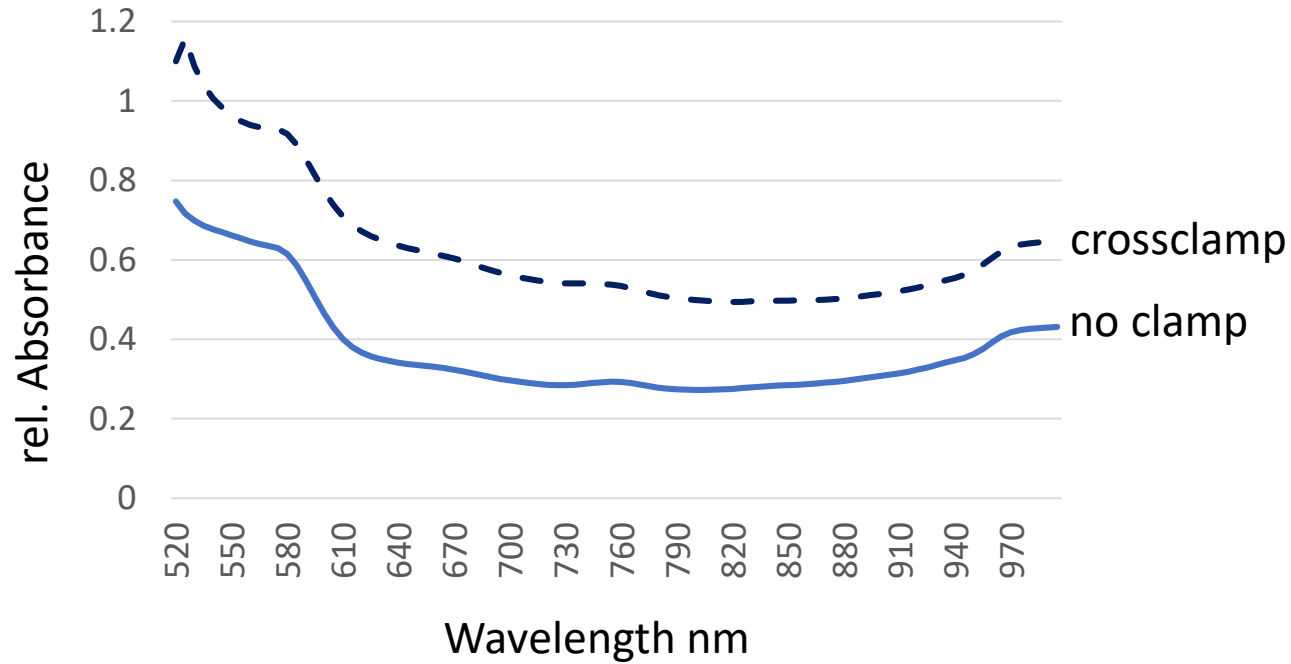
# Measured Tissue Spectra (Right Forehead) Before and During Crossclamping

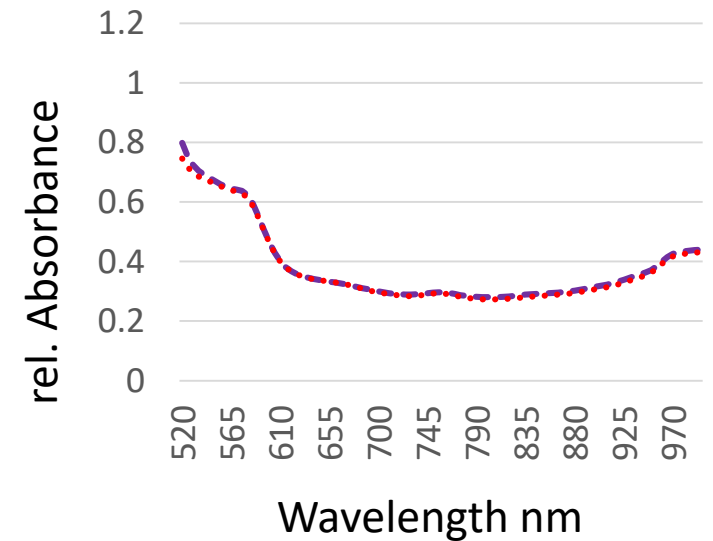
# Measured Tissue Spectra of Left and Right Forehead Before Crossclamping

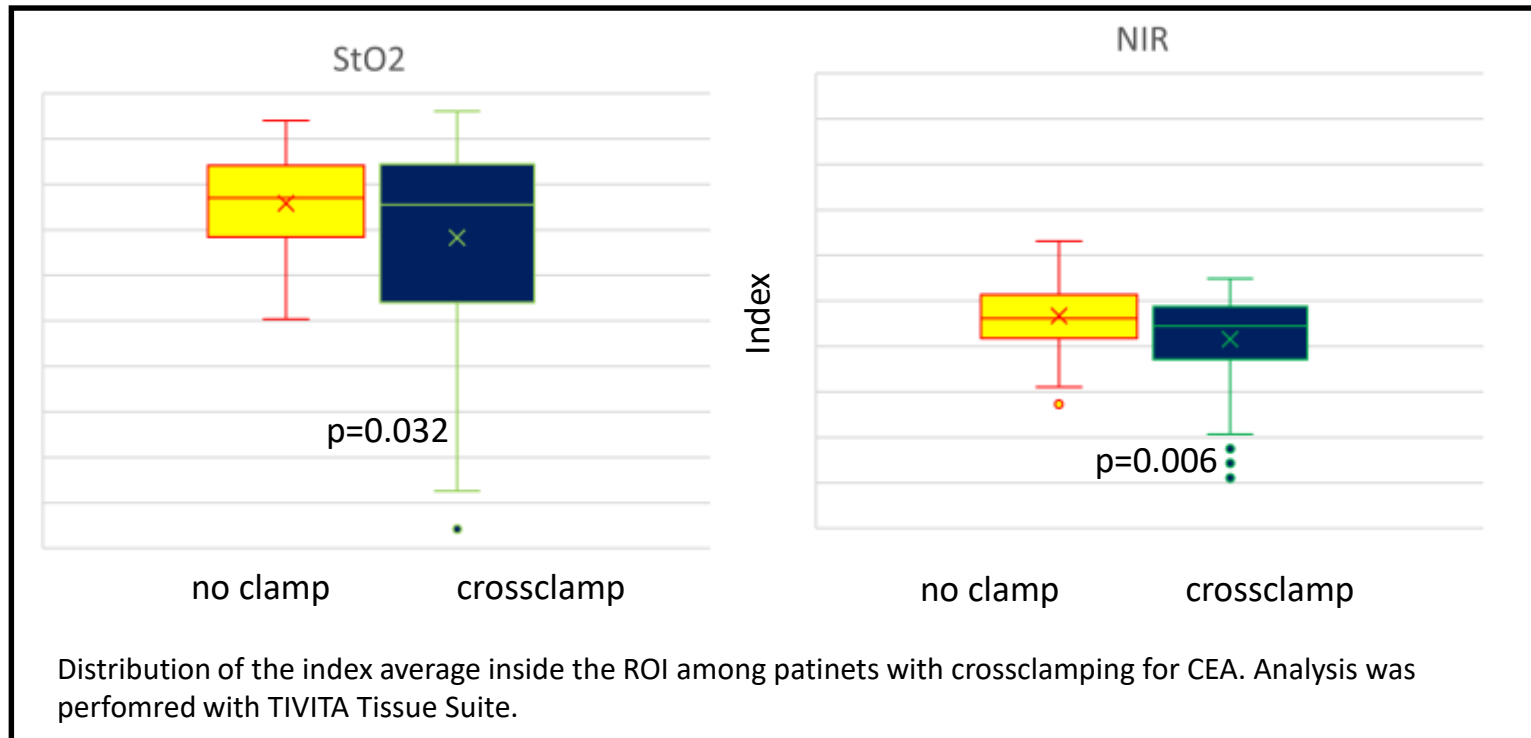
# Crossclamping During CEA Resulted in an Average 10% Decrease in Oxygenation (StO<sub>2</sub>) and 11% Decrease in Perfusion (NIR) in our cohort

Patient	decrease StO <sub>2</sub>	decrease NIR	NIRS decrease rSo <sub>2</sub>
1	20%	43%	31%
2	40%	17%	32%
3	n.s.	n.s.	2%
4	n.s.	11%	6%
5	n.s.	n.s.	n.s.
6	11%	5%	10%
7	n.s.	n.s.	n.s.
8	25%	17%	21%
9	n.s.	n.s.	n.s.
10	27%	22%	17%

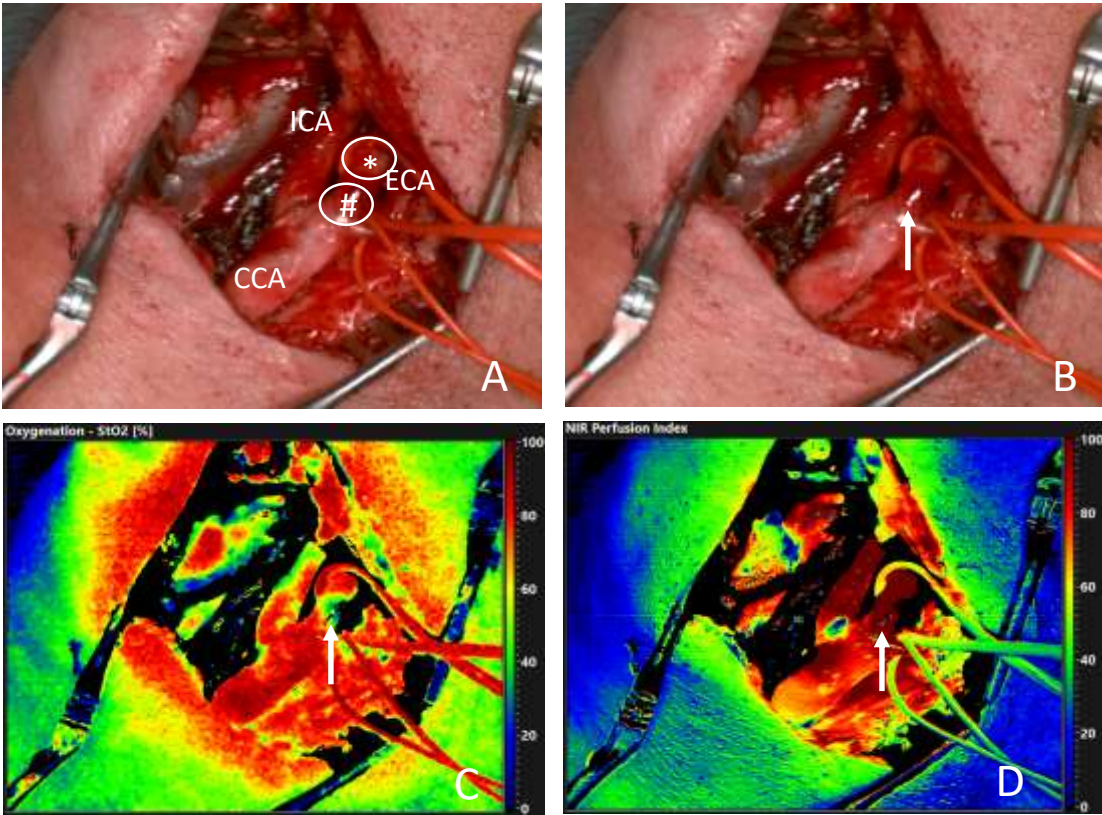
# Hyperspectral Imaging is a Useful Tool to Visualize and Quantify Collateral Damage of Vessel Wall Adventitia Caused by Vascular Clamps During CEA.

Intraoperative images during CEA surgery, acquired by the TIVITA<sup>®</sup> Hyperspectral Camera device. The RGB image (A) of the operation situs, displays the common carotid artery (CCA) and carotid bifurcation with the internal carotid artery (ICA) and external carotid artery (ECA). Region of interest (ROI) markers (white circles) were placed on the on the area where vascular clamps were applied (#) and on the unaffected vessel wall (\*) of the ECA for control. The white arrow in B, as an example, indicates the clamp injury on the ECA. False color images for (StO<sub>2</sub>) tissue oxygenation (C) and (NIR) near infrared tissue perfusion (D) display inhomogeneous vessel wall oxygenation and perfusion at the area of suspect clamp injury
